WH Response
A Division of Wright-Hennepin Cooperative Electric Association

NextGen Boiler – Stuck impeller on Wilo Circulator

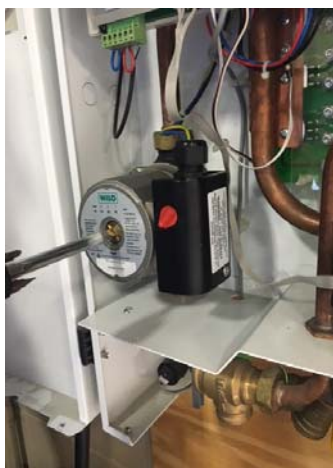
Figure 1

Step 2- Use a slotted screwdriver to remove the brass vent plug located in the center of the Wilo circulator. (Fig. 1) Note that you will observe a small amount of water coming out of the circulator.

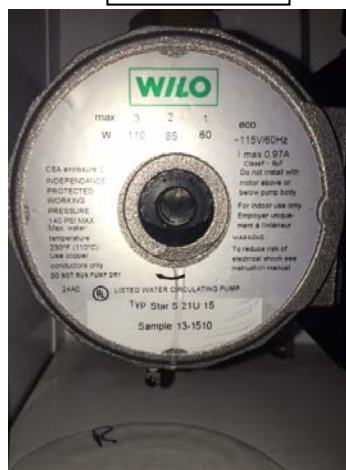
Figure 2

Step 3- Locate the impeller with the screwdriver slot within the interior portion of the pump. (Fig. 2)

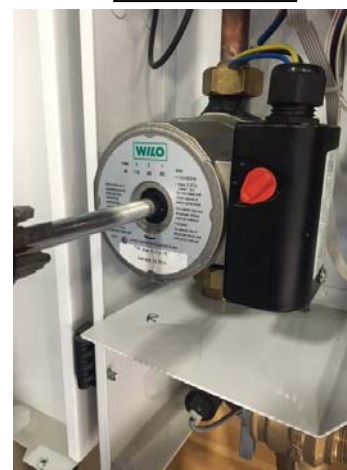
Figure 3

Step 4- Use a slotted screwdriver to turn the impeller a couple of revolutions. (Fig. 3) Replace vent plug.
